INSTALLATION RESTORATION PROGRAM

PRELIMINARY ASSESSMENT

GOLD KING CREEK RADIO RELAY STATION, ALASKA

April 1989

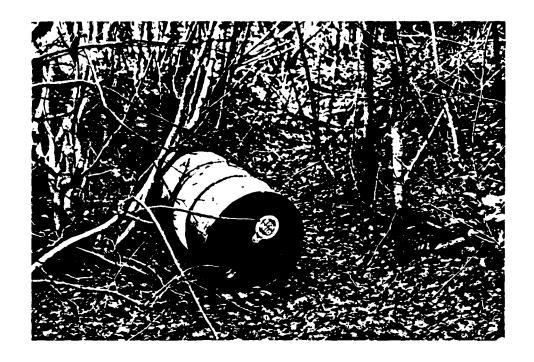
Photo 5. Empty drum in forest surrounding runway.
